STI-EXTERNAL

Company: AGP
 Location: Hastings, NE

Job ID: 652149
 Date: 8/4/2021
 Tank: DVOP 10

STI-INTERNAL

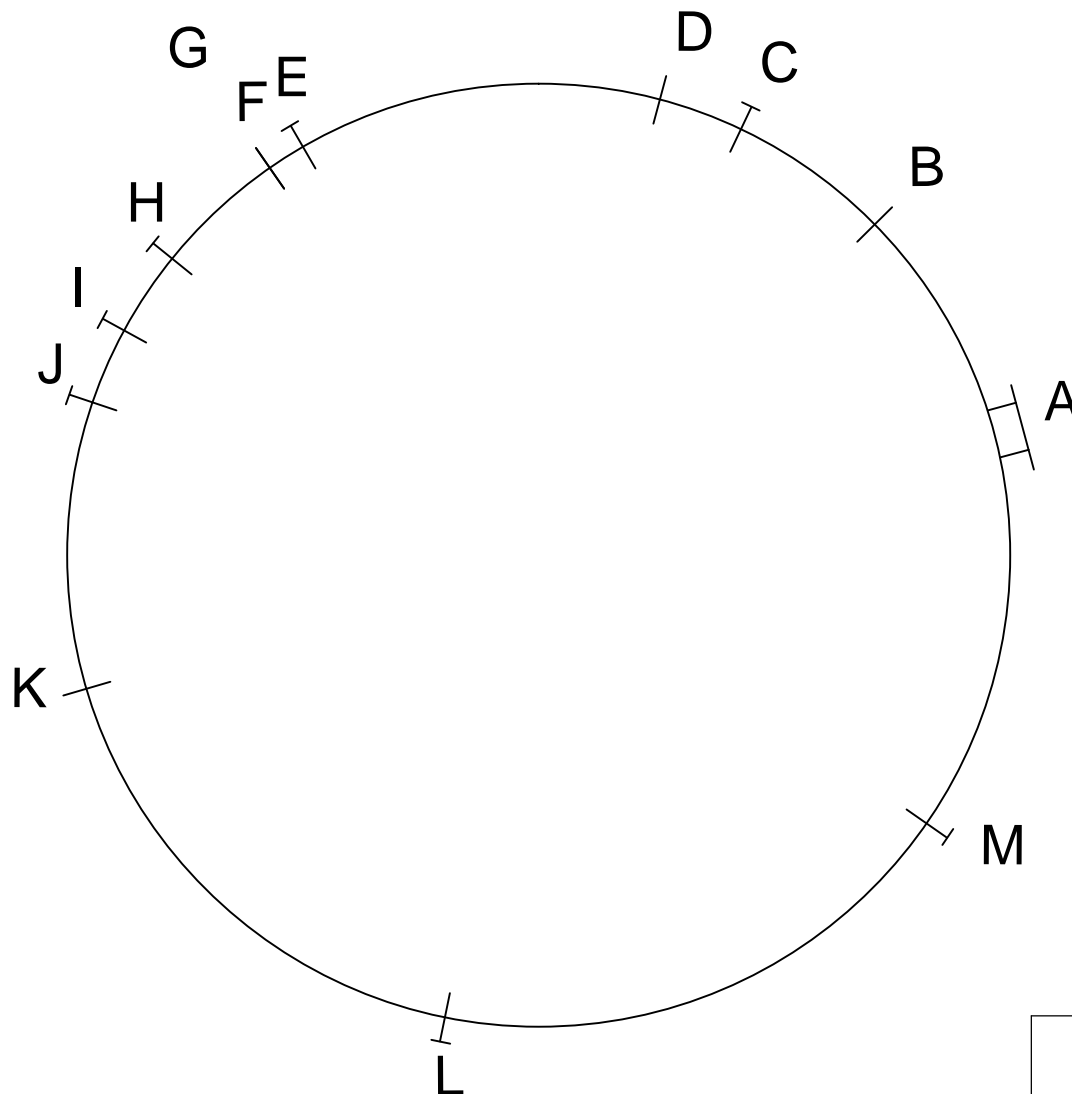
- Square Corner Inserts/Pads Lap Patches Unreinforced Penetration Split Repad
 No Telltale Hole in Repad Plugged Telltale Hole in Repad Improper Weld Space
 Insufficient Reinforcement Undersize Insert Cover Plate Thin Flange Thin
Shell Nozzles A, H, I, J, and K were over 2 inches in diameter and did not have repads.

The repads of Shell Items C, L, and M did not have telltale holes.

Shell Nozzles A, H, I, J, and K were over 2 inches in diameter and did not have repads. **Since the shell is over the required thickness, no additional reinforcement is required.**

The repads of Shell Items C, L, and M did not have telltale holes. **No action is required.**

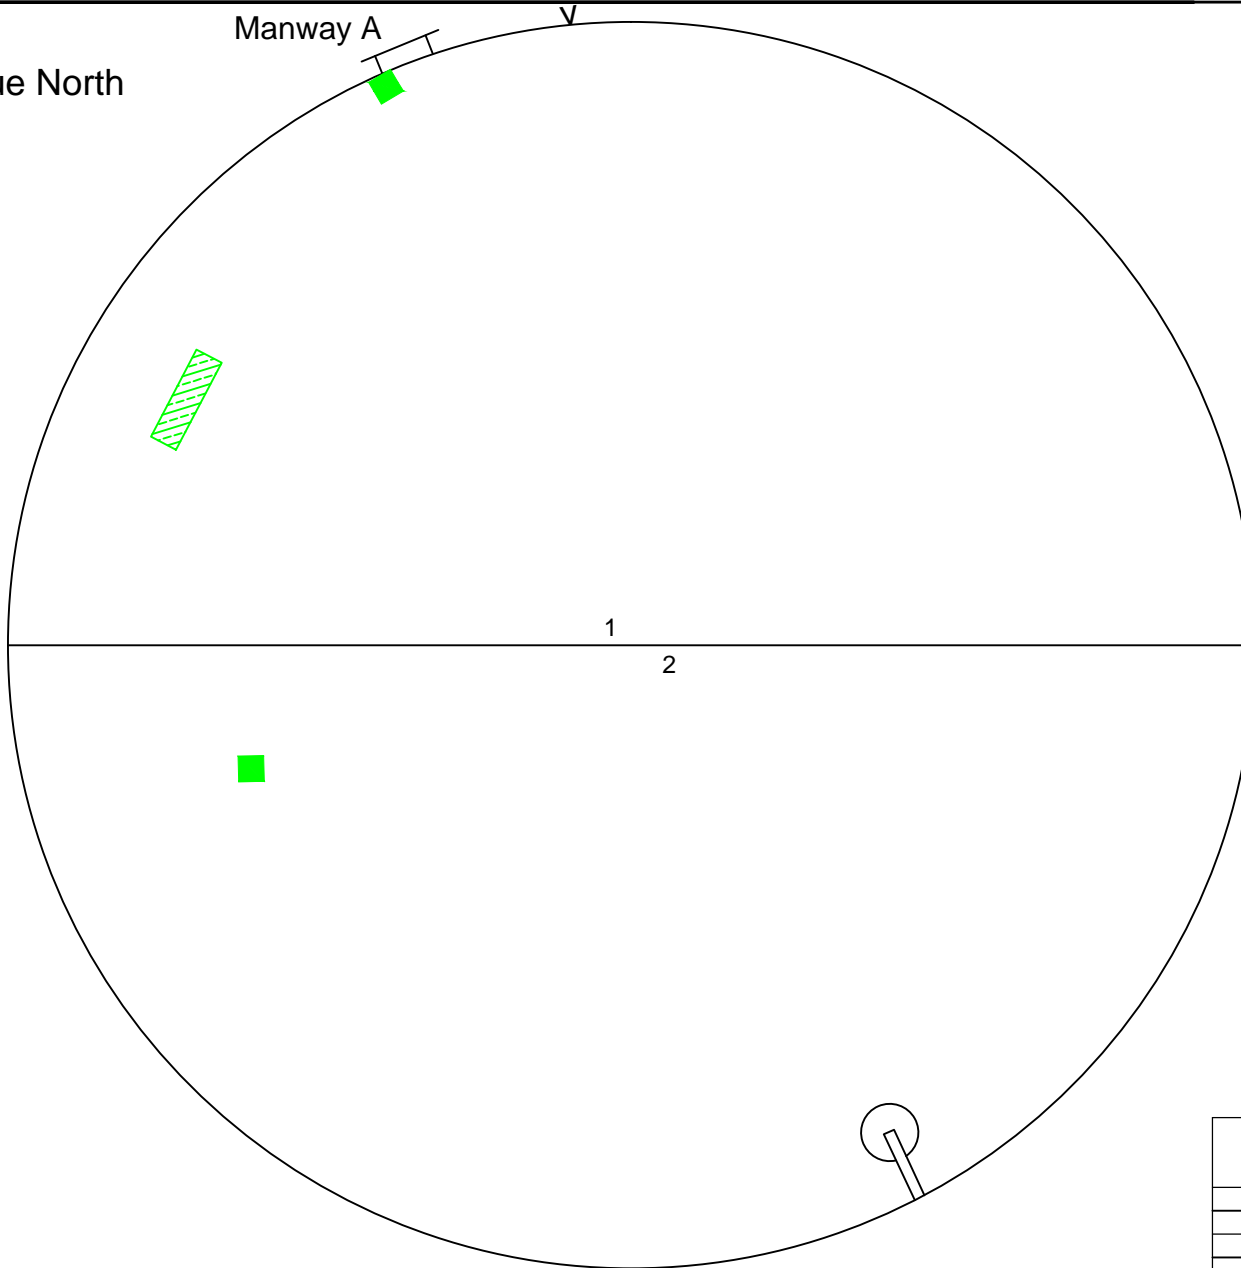
There were two soilside indications and one area of soilside corrosion below the thresholds. One soilside indication was located in the critical zone. These areas were marked for repair. A 5-year inspection interval was used.

A Magnetic Flux Leakage (MFL) scan was performed on the tank bottom at a remaining wall threshold of 0.150 inches thick in the bottom plates and 0.170 inches thick in the critical zone (within three inches of the shell) for a 5-year inspection interval. There were two soilside indications and one area of soilside corrosion below the thresholds. One soilside indication was located in the critical zone. These areas were marked for repair. The lowest readings were 0.130 inches and located on Bottom Plate 1. **The corroded areas should be patched per API 653 standards.**
