Job No:	652131	
		Tank Num:	DVOP 11	
		Date:	07-14-2021	
Customer:	AGP			
Location:	Hastings, NE			
	Diameter:	12.00	Height:	42.00
	Drawn by:	A Frye	Rev:

STI-INTERNAL

Job ID: 652131
 Date: 7/14/2021
 Tank: DVOP 11

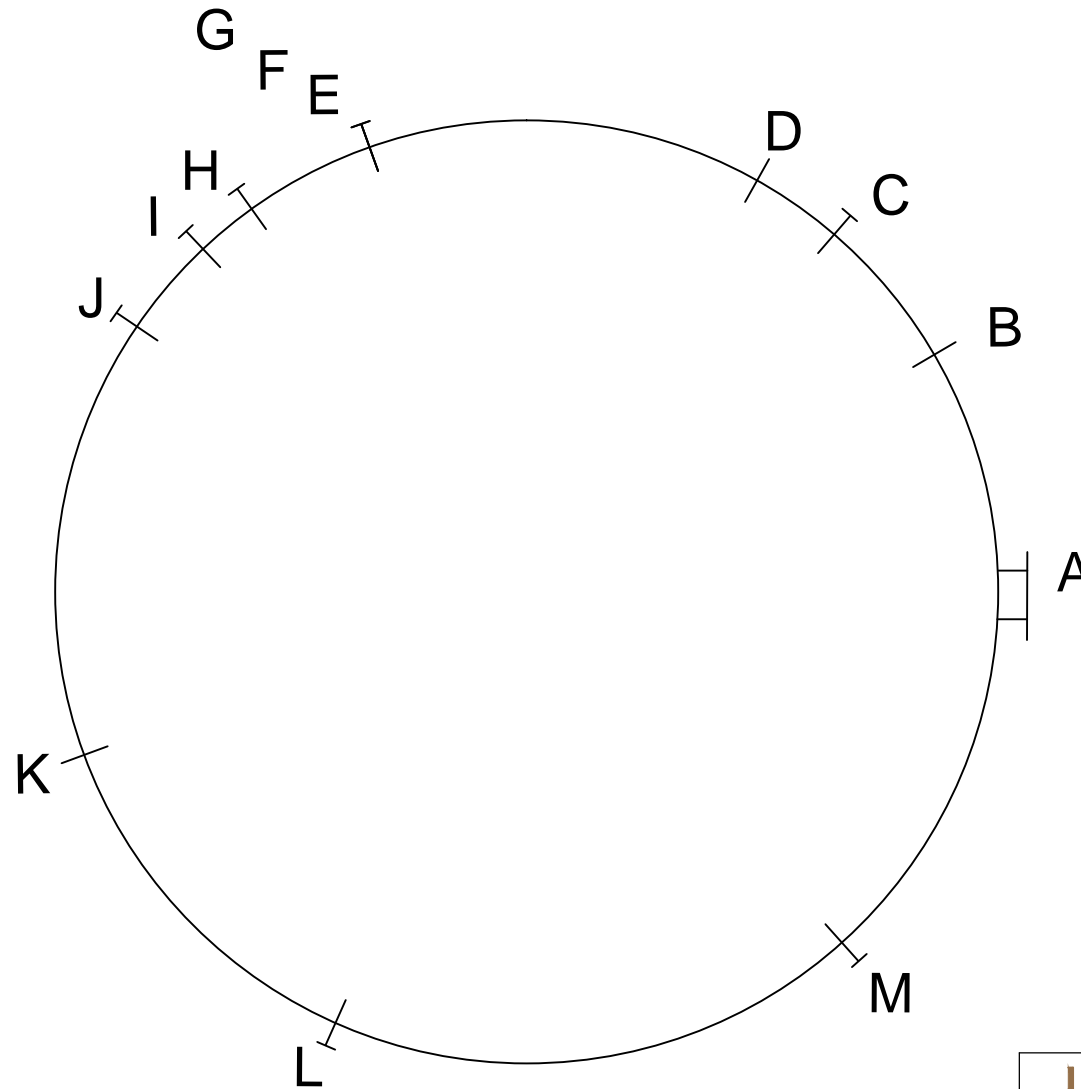
The repads of Shell Items C, L, and M did not have telltale holes.

The weld spacing of Shell Items C and G did not meet API standards.

Shell Items A, H, I, and J were over 2 inches in diameter and did not have repads.

The repads of Shell Items C, L, and M did not have telltale holes. **Consideration should be given to drilling and tapping telltale holes in the repads, pressure testing the neck and repad welds.**

The weld spacing of Shell Items C and G did not meet API standards. **Since the tank shell is 0.5 inches or less in thickness, no corrective action is required.**

Shell Items A, H, I, and J were over 2 inches in diameter and did not have repads. **Since the shell thickness is over twice the required thickness no action is required.**
