**Tank Inspector(s)** J. Martin (STI #AC 32455) and M. Emert

Job No:	652009	
		Tank Num:	DVOP8	
		Date:	06-08-2021	
Customer:	AGP			
Location:	Hastings, NE			
	Diameter:	12.00	Height:	42.00
	Drawn by:	A Frye	Rev:

STI-INTERNAL

Job ID: 652009  
 Date: 6/8/2021  
 Tank: DVOP8

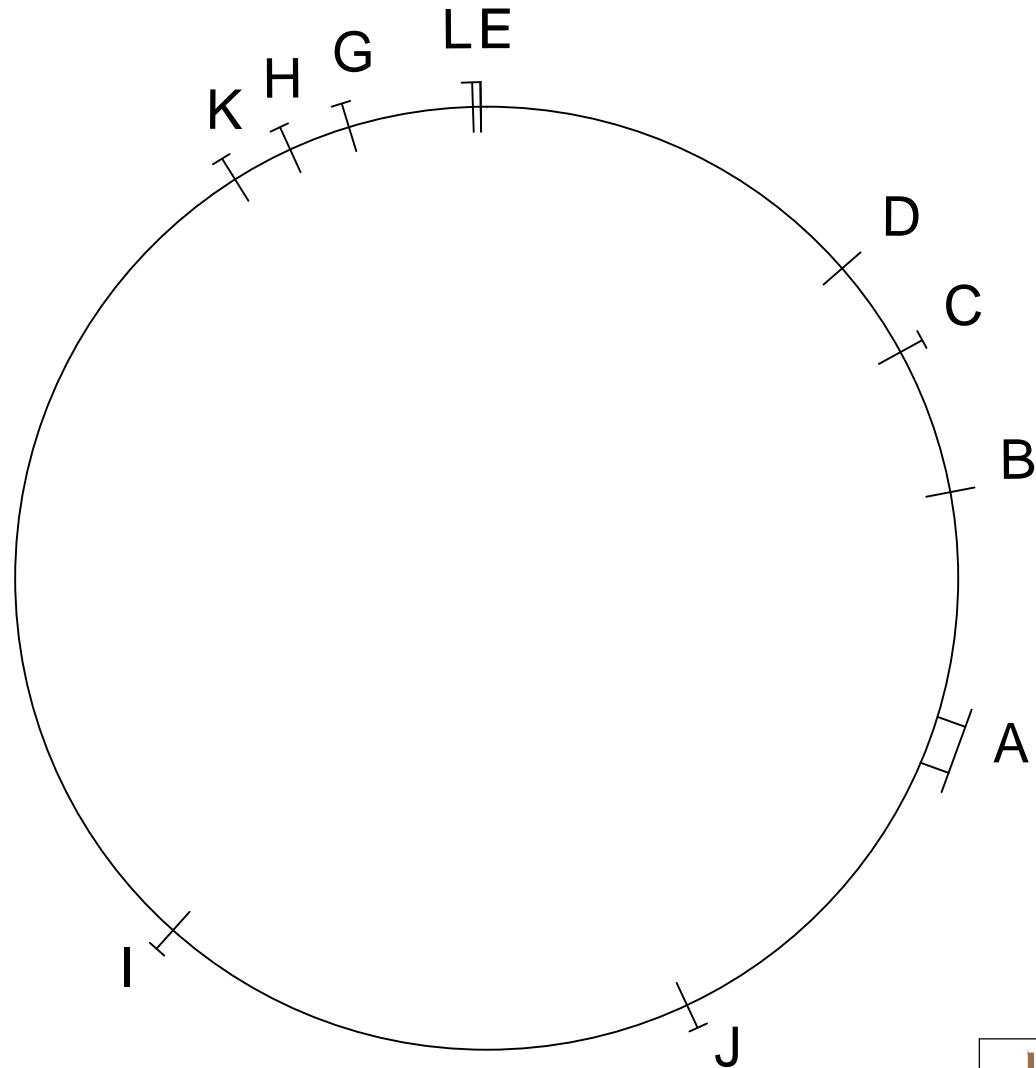
The repads of Shell Items C, I, and J did not have telltale holes.

The weld spacing of Shell Items C and G did not meet API standards

Shell Nozzles A, G, and H were over 2 inches in diameter and did not have repads.

There was a pinhole in the internal weld of Shell Item E. There was undercut and pinholes in the internal welds of Shell Items F.

The repads of Shell Items C, I, and J did not have telltale holes. **Consideration should be given to drilling and tapping telltale holes in the repads, pressure testing the neck and repad welds.**

The weld spacing of Shell Items C and G did not meet API standards. **Since the tank shell is 0.5 inches or less in thickness, no corrective action is required.**

Shell Nozzles A, G, and H were over 2 inches in diameter and did not have repads. **Since the shell thickness is over twice the required thickness no action is required.**

There was a pinhole in the internal weld of Shell Item E. There was undercut and pinholes in the internal welds of Shell Items F. **Consideration should be given to weld repairing these areas.**
