**Tank Inspector(s)** J. Martin (STI #AC 32455) and M. Emert

Job No:	652130	
		Tank Num:	DVOP 9	
		Date:	07-14-2021	
Customer:	AGP			
Location:	Hastings, NE			
	Diameter:	12.00	Height:	42.00
	Drawn by:	A Frye	Rev:

Job ID: 652130  
 Date: 7/14/2021  
 Tank: DVOP 9

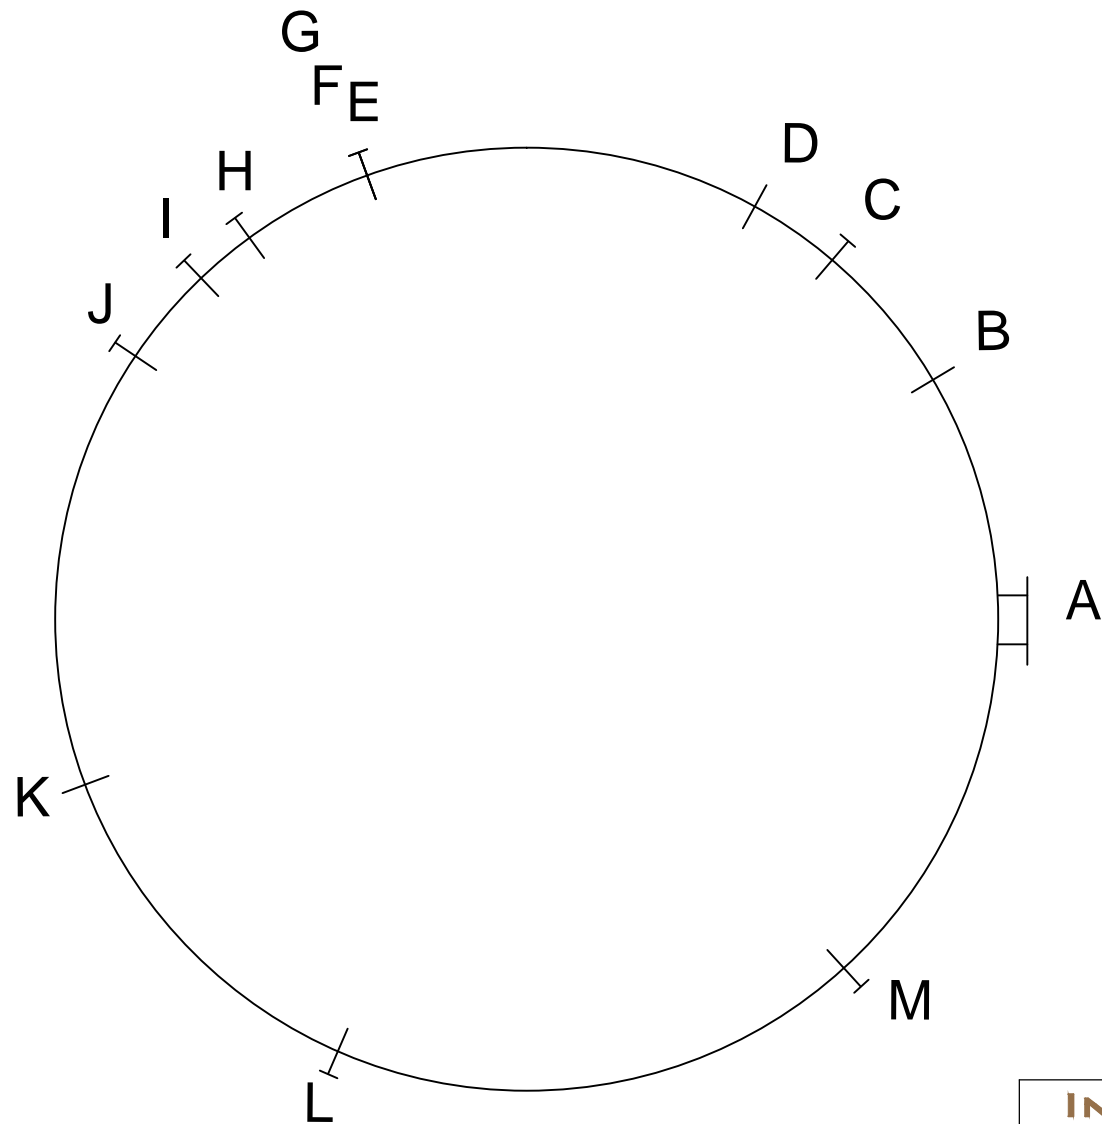
The repads of Shell Items C, L, and M did not have telltale holes.

The weld spacing of Shell Items C and G did not meet API standards.

Shell Items A, H, I, and J were over 2 inches in diameter and did not have repads.

The repads of Shell Items C, L, and M did not have telltale holes. **Consideration should be given to drilling and tapping telltale holes in the repads, pressure testing the neck and repad welds.**

The weld spacing of Shell Items C and G did not meet API standards. **Since the tank shell is 0.5 inches or less in thickness, no corrective action is required.**

Shell Items A, H, I, and J were over 2 inches in diameter and did not have repads. **Since the shell thickness is over twice the required thickness no action is required.**

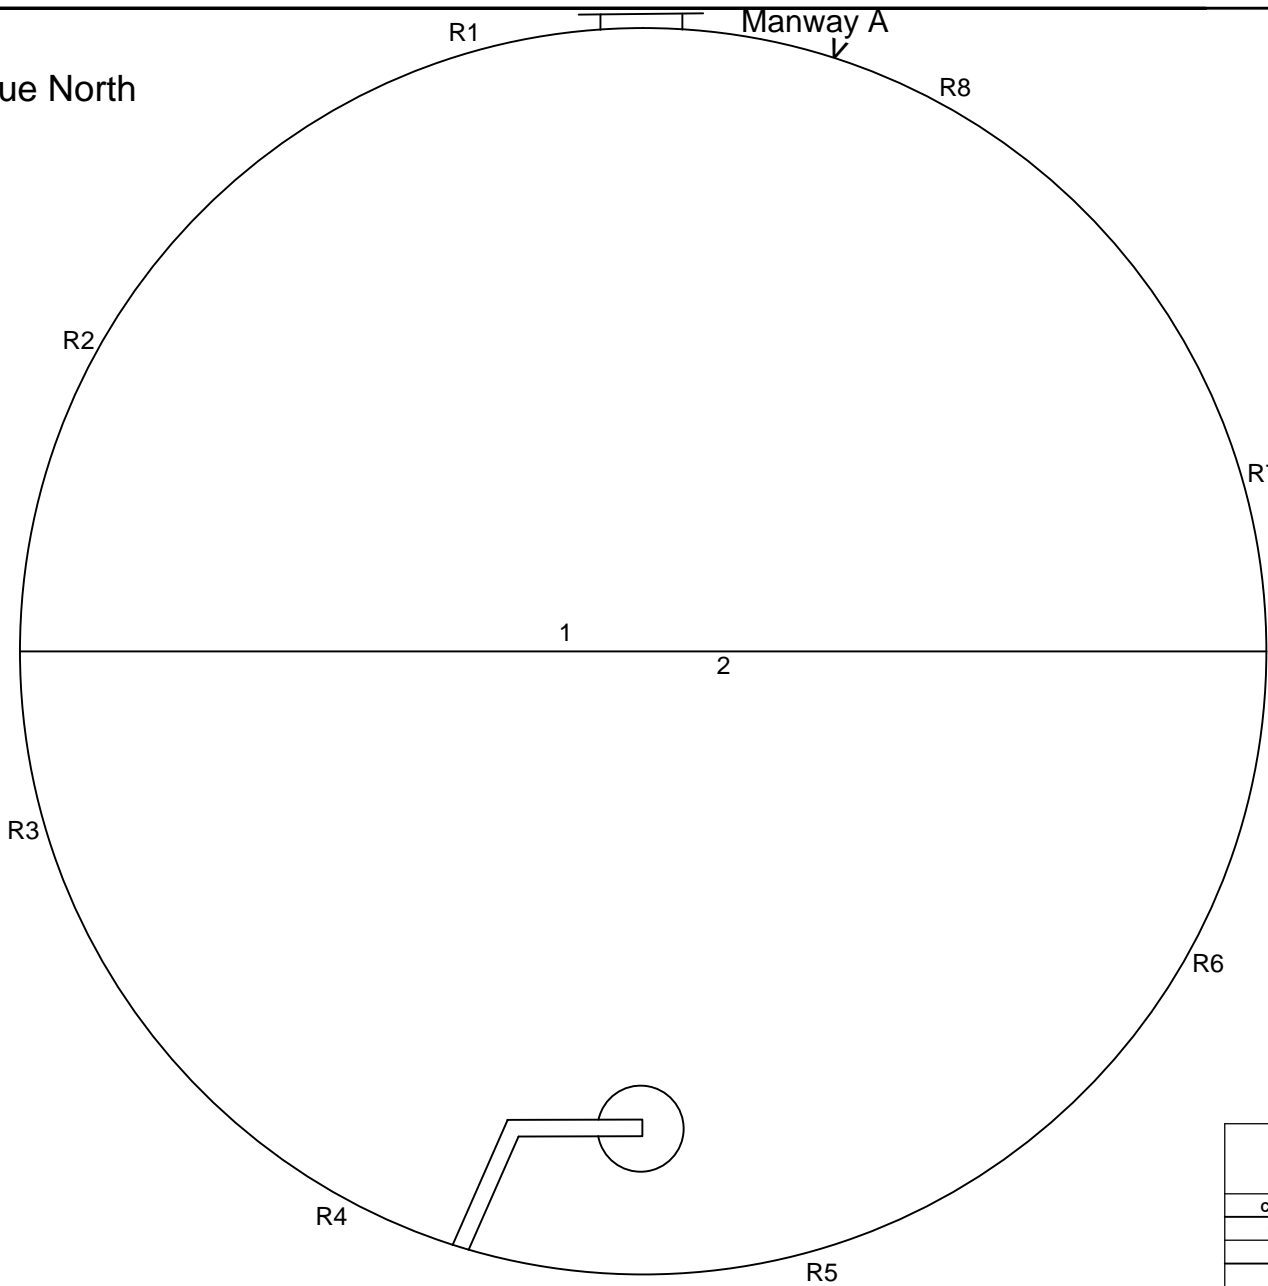
Job No:	652130
		Date:	07-14-2021
		Tank Num:	DVOP 9
Customer:	AGP		
Location:	Hastings, NE		
Diameter:	12.00	Height:	42.00
Drawn by:	J. Bachman	Rev:

There were no topside pits detected below the thresholds. A 10-year inspection interval was used.

There were no areas of soilside corrosion below the thresholds. A 10-year inspection interval was used.
