AEGIS Inspection Services LLC Inspection Report

Unit ID:	Distillation	Event:	2016 shutdown
Equipment ID:	C-4201	Date of Inspection:	9/2/16
Equipment Name/ Service:	Rectifier Column	Inspected By:	Corey Enrietti
Equipment Type:	Tower	Client:	Ergon Biofuels

Tower Internal Inspection Report

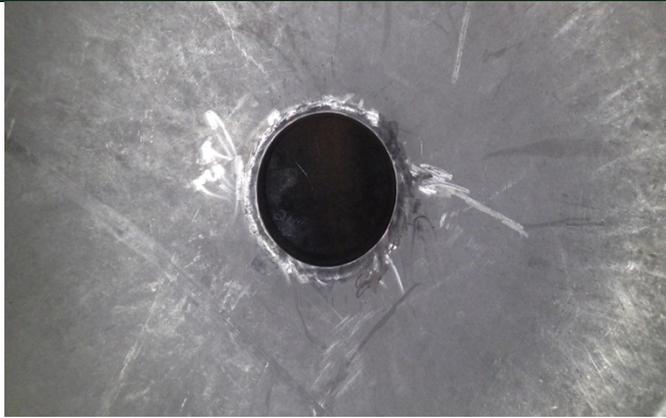
OVHD Nozzle

All visible nozzles in the upper and lower section were clear of debris with no visible corrosion or erosion present. All nozzle back welds were ground smooth to the base metal. The 3/4” threaded couplings throughout the tower were not back welded due to not being correctly beveled at time of installation. No evidence of preferential corrosion or damage was visible at the nozzle back welds. The top and bottom manway gasket seating surfaces were free of mechanical or service induced damage at time of inspection.

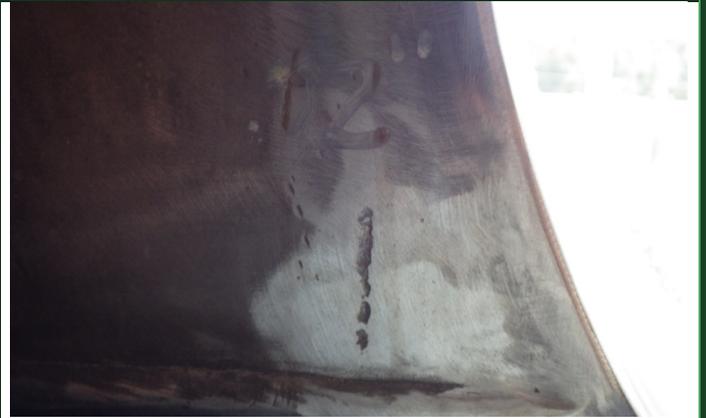
The shell of the tower from top to bottom had isolated scattered pitting up to 0.010” in depth. Random areas of mechanical damage were found throughout the column with a maximum depth of 0.030 inch. The shell also showed slight distortions due to manufacture defects. All visible circumferential and longitudinal weld seams were full profile and in a comparable condition to the shell base metal with the exception of a few locations where the welds were found ground flush to the shell.

Mechanical Damage

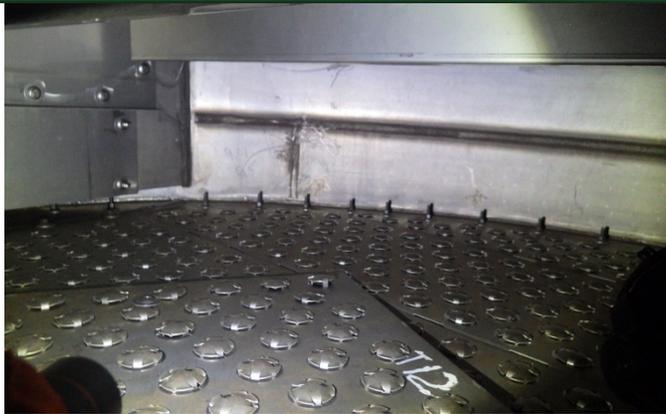
Typical Tray

The tray rings were seal welded on the top and bottom with no issues noted to the welds. The tray rings were found to be full thickness with no signs of damage or corrosion. The tray decks were secured and near full thickness. Trays 18-20 were replaced at this time due to being damaged during operation.

1. Trays 18-20 were replaced; the trays were found lying in the bottom head when the tower was opened.
2. Missing tray valves and tray hardware was replaced.

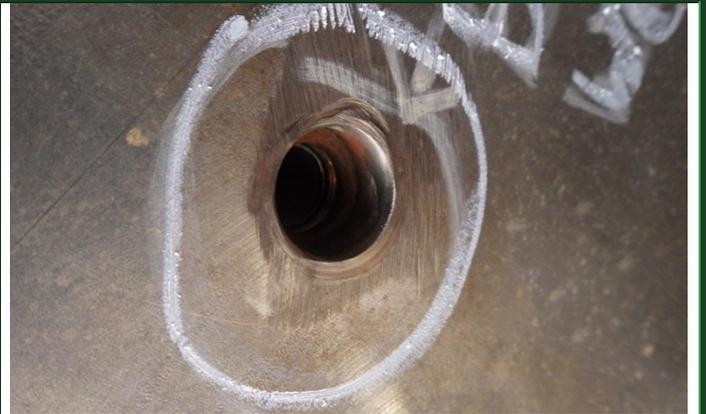
$\frac{3}{4}$ " not back welded

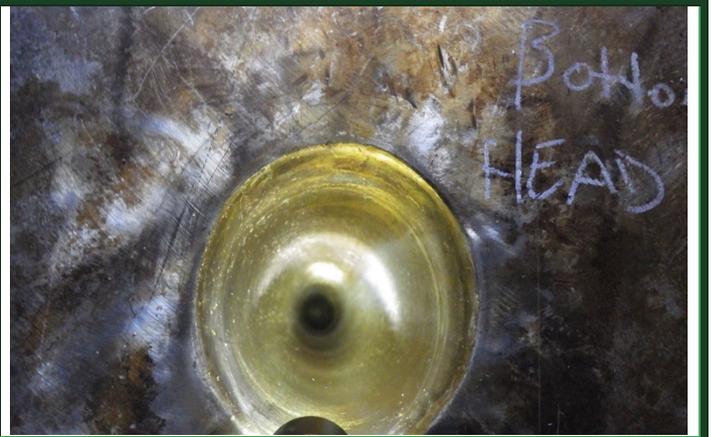
Bottom Head and Nozzle

The top and bottom head had minor surface roughness less than 0.010” in depth. There was mechanical damage noted throughout both heads, this mechanical damage was from manufacturing process (welding, grinding, ect.) and with no measureable depth. No bulges or distortions were noted.
